Pre-war *Tong Lau*: A Hong Kong Shophouse Typology

Lee Ho Yin

Architectural Conservation Programme (ACP)
Faculty of Architecture, The University of Hong Kong

A Resource Paper for the
Antiquities and Monuments Office and Commissioner for Heritage's Office

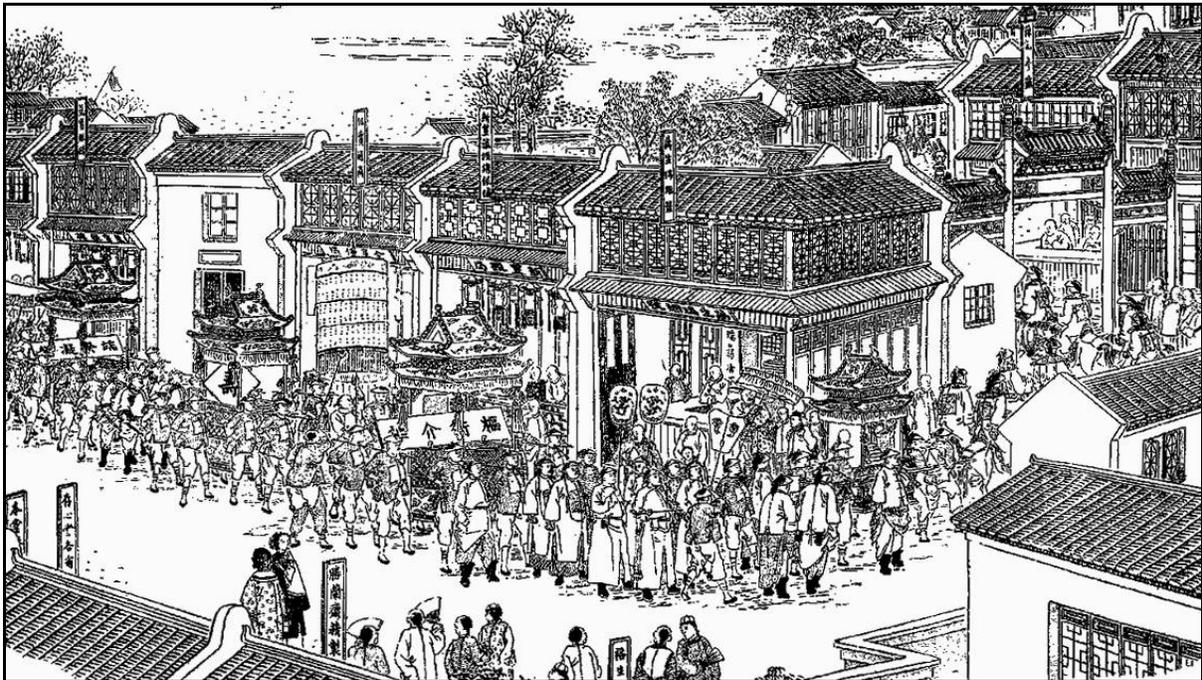
Fig. 1 A drawing by the 19th-century Shanghai-based illustrator Wu Youru (吳友如), depicting a Southern Chinese urban street scene lined with shophouses. (Source: 十九世紀中國風情畫二百圖)

Tong Lau (functioning as singular and plural; 唐樓, literally, “Chinese building”) belongs to the generic urban shophouse typology found in predominantly Chinese cities in Southern China and Southeast Asia, such as Hong Kong, Guangzhou, Macau, Singapore and Penang. It is a typology that has infused with material, construction and living traditions of Southern Chinese in 19th-century urban centres, particularly towns and cities in Guangdong and Fujian provinces. The prototype of this typology is the 19th century urban shophouse of Southern China (**Fig. 1**). This paper focuses on *Tong Lau* of Hong Kong built before the Pacific War (1941-45).

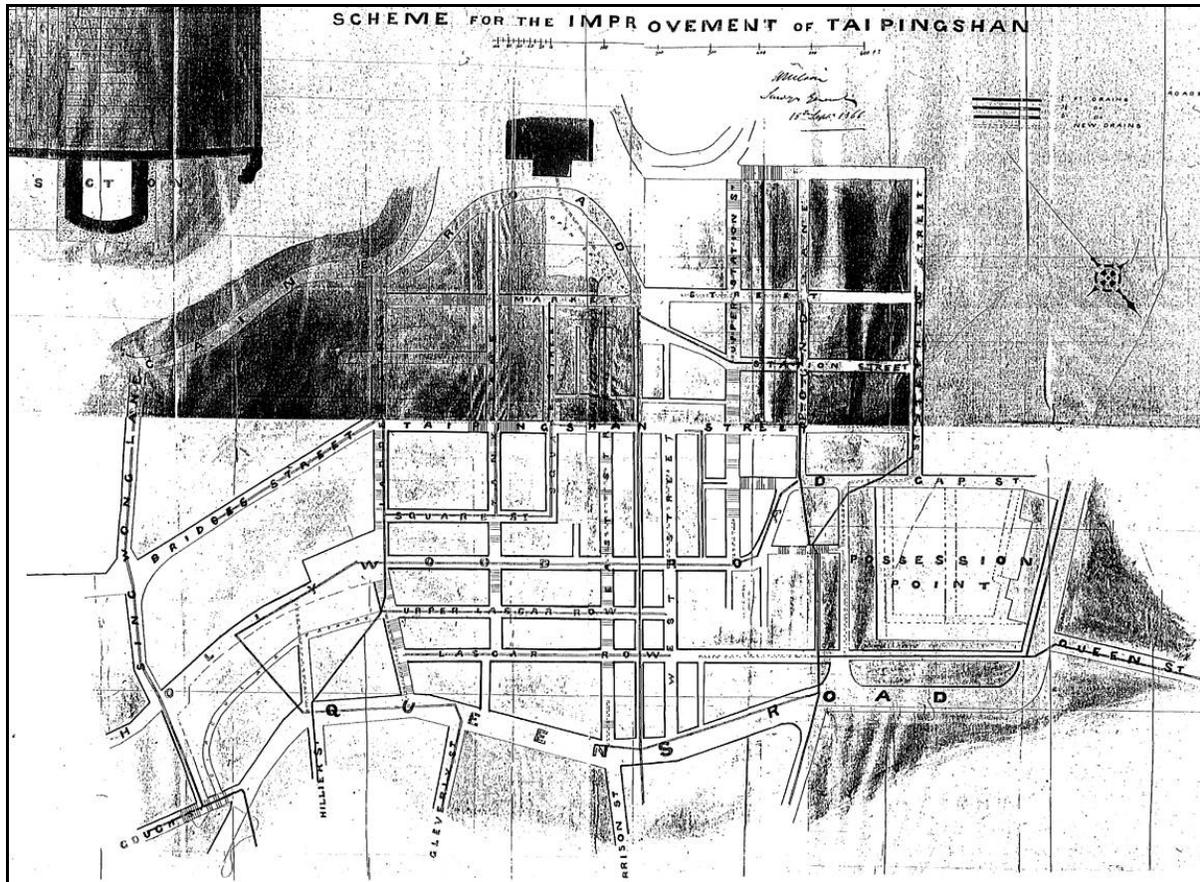
Fig. 5 The 1866 map (the date is shown under the signature of the Surveyor General) entitled “Scheme for the Improvement of Tai Ping Shan, showing the extent of district, as indicated by the smaller lots typically developed for Chinese shophouses. (Source: Public Records Office, Hong Kong.)

As shown in the map *Scheme for the Improvement of Tai Ping Shan* (**Fig. 5**), dated 15 September 1866 (below), the fully developed Tai Ping Shan was an area roughly 300 m by 250 m and bounded by Caine Road in the south, Queen's Road (today's Queen's Road Central) in the north, Sing Wong Lane (today's Shing Wong Street) in the east and St. Stephen Street (today's Po Yan Street) in the west. By the eve of the bubonic plague outbreak in 1894, Tai Ping Shan was the main urban Chinese settlement in the City of Victoria, supporting a sizable percentage of the estimated 210,000 Chinese in Hong Kong (Pryor 1975: 65).

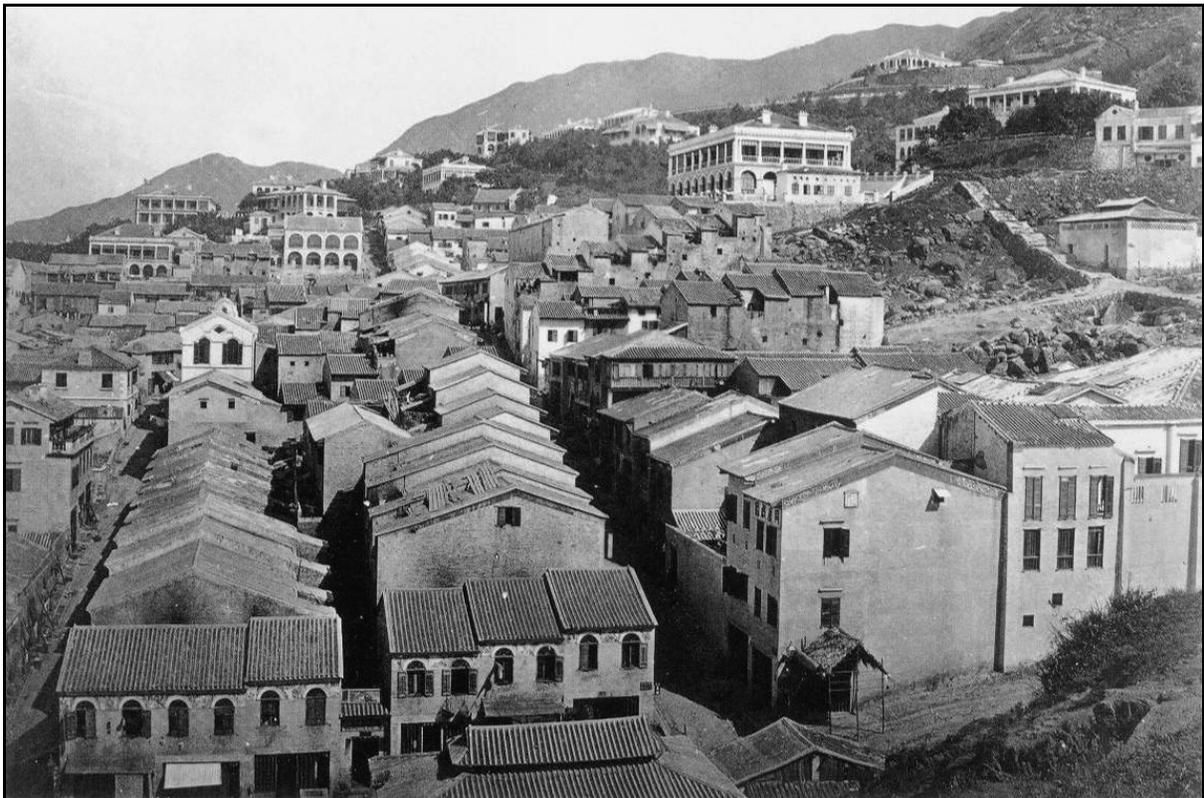
Fig. 6 Tai Ping Shan in the 1870s, showing the earliest form of Hong Kong *Tong Lau*, which were broadly similar in appearance and construction with those found in towns and cities of Southern China during this period, but were different in decorative details and size. (Source: Hong Kong Museum of History)

Although the architecture of early *Tong Lau* in Hong Kong was broadly similar to those in Southern China, Chadwick observed that there were noticeable differences due to “European influence and example, but principally to the necessity for economy of space on account of the high price of land and the great cost of preparing level sites for building” (*Chadwick’s Report*, in Faure 1997: 34). This means that the local conditions did have an effect in transforming even the early *Tong Lau*, which featured decorative elements inspired by Western Classical architecture and, more significantly, were more compact than their Mainland counterparts (**Fig. 6**).

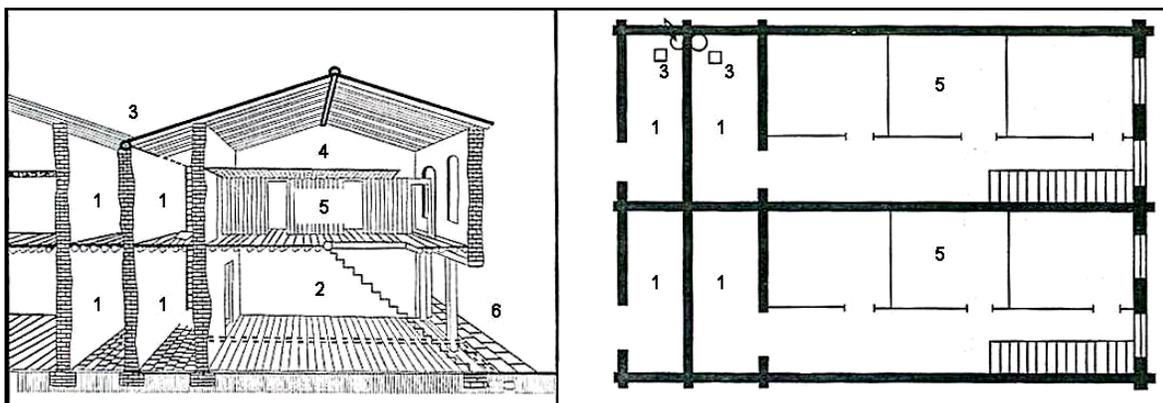
Fig. 7 Drawings depicting the section and plan of an early *Tong Lau* found at Tai Ping Shan in the early 1880s. In the drawings, 1 = cookhouses; 2 = shop; 3 = smoke hole through the roof and floor; 4 = cockloft or platform above tenement cabins; 5 = tenement cabins; 6 = street in front of building. (Source: *Chadwick's Report* (1882) in Faure 1997: 34 and 35)

Building Frontage Each unit, of two to three storey high and between 13 to 16 feet wide (about 4 to 5 m), was separated from adjacent units by brick party walls. A large unit for the wealthy was formed by uniting several narrow units by doors or archways in the party walls.

Building Depth The building measured about 30 to 60 feet from front to back (about 9 to 18 m), and two rows of buildings were built back to back with a common back wall and no space between them (this would change with the post-plague *Public Health and Buildings Ordinance 1903*, which reduced the building depth and introduced a scavenging lane, or service back lane, for waste disposal).

Service Areas A space of about 7 feet deep (about 2 m) at the back of the building was separated by a wall from the rest of the building. This is the “cookhouse,” which also served as the kitchen, toilet and the backyard. Venting of cooking fire was by means of a 4 to 5 feet square (1.2 to 1.5 m square) “smoke hole” through the upper floor(s) and the roof, or simply through windows. Chimneys were the exception. Compliance to the Ordinance 8 of 1856 that required every house to be “provided with a latrine or privy and ashpit” was rarely observed. The construction of waste water drainage was unregulated and often inadequate, if available.

Served Areas The ground floor of a *Tong Lau* was used as shop space, but a cockloft was often built on the upper space in front of the partition wall of the cookhouse, and used as working or sleeping quarters. The upper floor was partitioned into cabins of about 10 by 10 feet wide (about 3 m²) above which was a cockloft level that was similarly divided. Each cabin housed an individual or a family, and Chadwick inspected one tenement unit and found five families of 16 people living on one floor. Chadwick reported the case of a row of eight small houses that provided tenement lodging for 428 inhabitants, who were common labourers, each of whom had 230 cubic feet of space (about 20 m³) (Faure 1997: 46). It was reported in 1874 edition of the *Hong Kong Annual Report* that pigs and poultry were

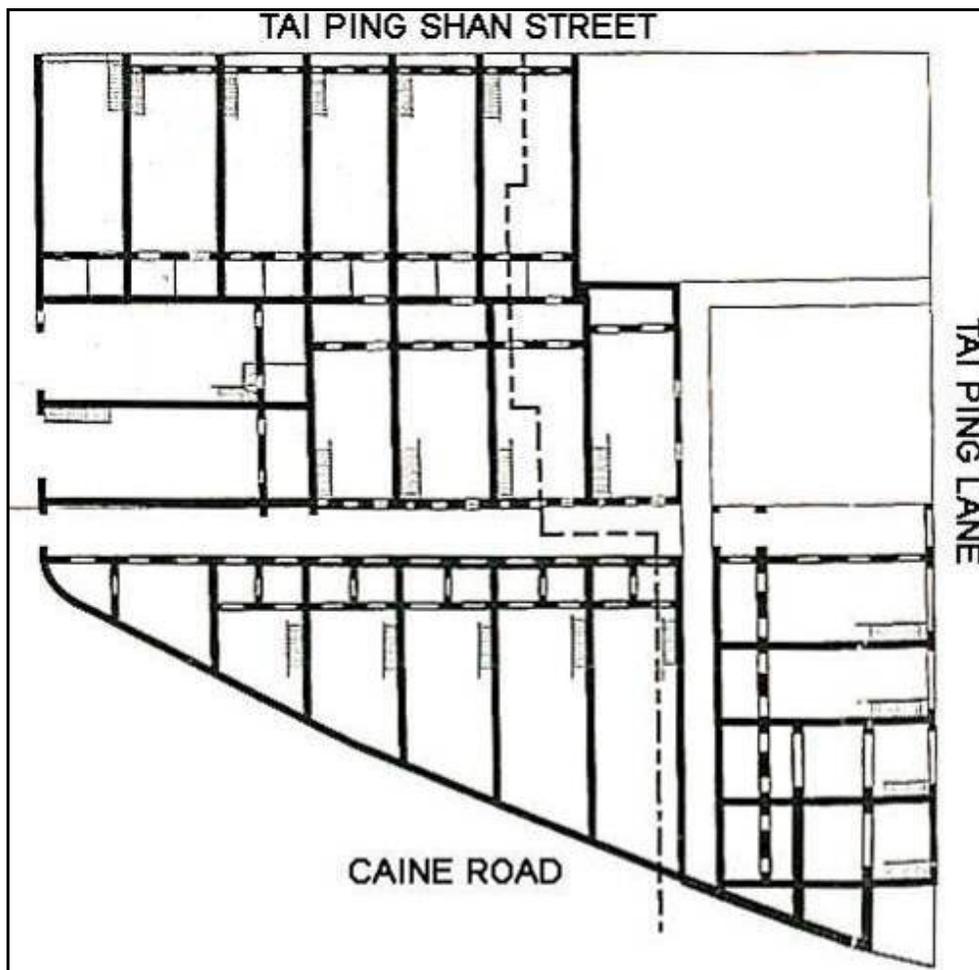
Fig. 8 Block plan of several rows of early *Tong Lau* at Tai Ping Shan, early 1880s. (Source: *Chadwick's Report* (1882) in Faure 1997: 44)

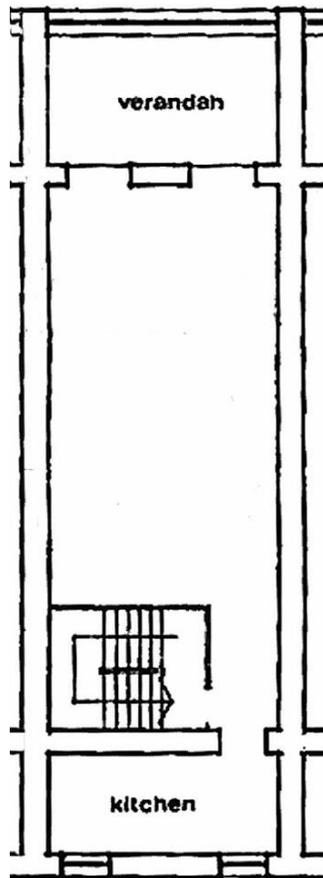
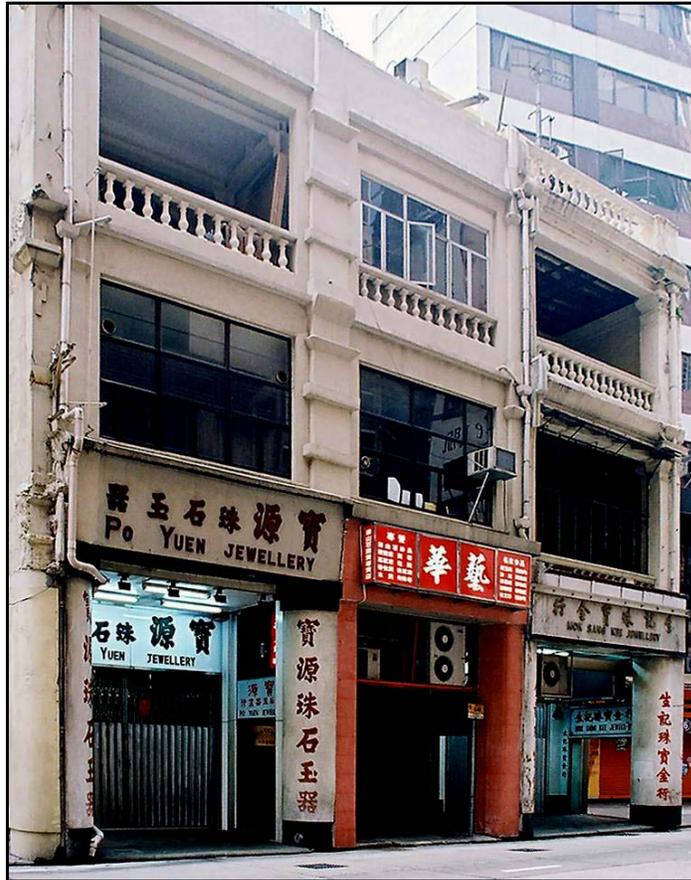
5.2 Verandah Type

Date: After 1903 and before 1935, but mostly the 1920s and the early 1930s.

Structure: 1½ ft (about 0.5 m) load bearing brick party wall with round fir floor beam; verandah of masonry or reinforced concrete, or timber for earlier buildings.

Frontage: 15 ft (about 4.5 m)

Height: 2 to 4 storeys; ground floor about 16 ft (5 m) high and each of the upper floors about 13 ft (4 m) high.

Floor area: 550 to 700 sq ft (about 50 to 65 m²) per floor.

- Features:
1. The 4th storey usually set back from the street.
 2. Verandah supported by brick piers projects over the whole width of the pavement to form a covered arcade at street level.
 3. A stairwell separates the living area from the cookhouse.
 4. Balustrade consists of Classical-style posts supporting a granite rail.
 5. The kitchen (cookhouse) of earlier designs (1920s and earlier) may take up the entire width of the back of the building, with openings to the back lane, whereas the kitchen of later designs (early 1930s) may take up half the width of the back of the building, and opens into the back lane and the open space at the back of the building.
 6. Not equipped with toilet.

Example: 290 Queen's Road Central.

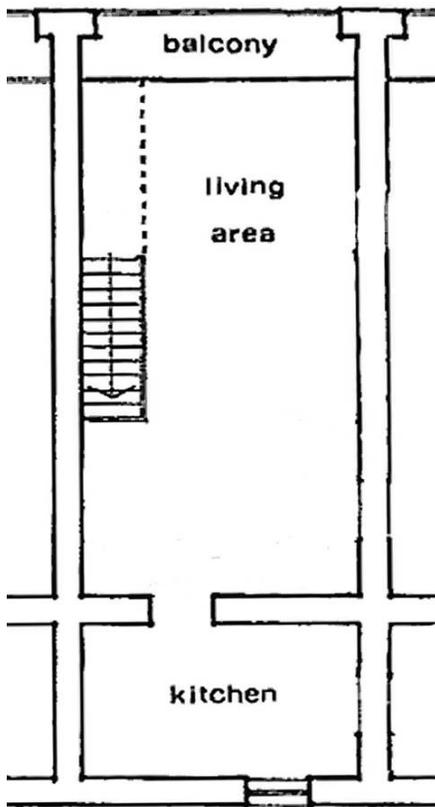
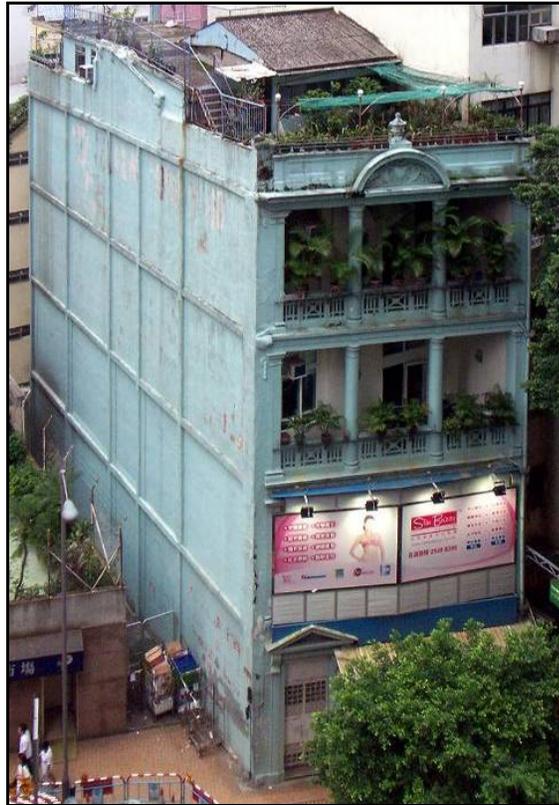
5.3 Recessed Balcony Type

Date: After 1903 and before 1935, but mostly the 1920s.

Structure: $1\frac{1}{2}$ ft (about 0.5 m) load bearing brick party wall with round fir floor beam.

Frontage: 15 ft (4.6 m).

Height: Usually 3 storeys.

Floor area: Average 650 sq ft (about 60 m²) per floor.

- Features:
1. Facade of each floor recessed to form a balcony of about two feet deep.
 2. No light well, pitched roof over the living area and flat roof over the kitchen area.
 3. The kitchen takes up the entire rear portion of the building, with openings to the back lane.
 4. Not equipped with toilet.

Example: 35 Bonham Road.

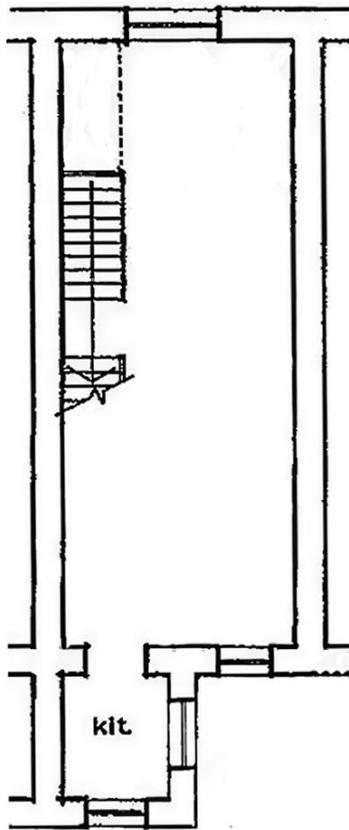
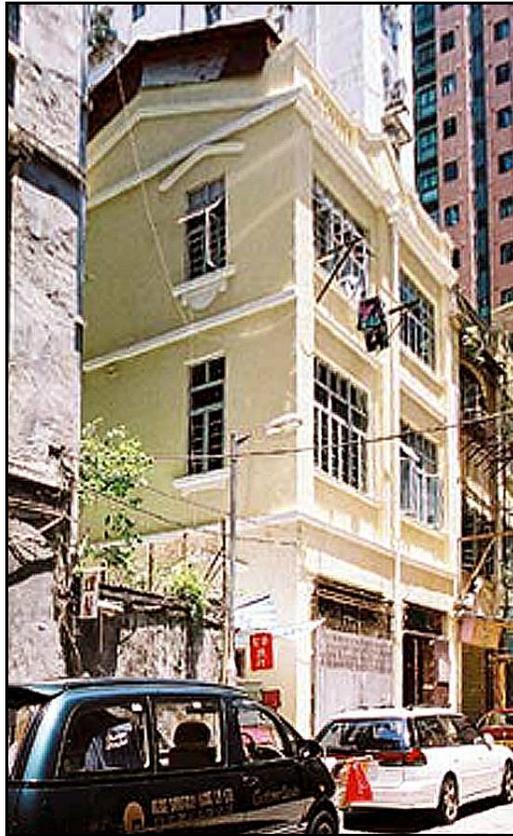
5.4 Flat Facade Type

Date: After 1903 and before 1935, but mostly the 1920s.

Structure: $1\frac{1}{2}$ ft (about 0.5 m) load bearing brick party wall with round fir floor beam.

Frontage: 15 ft (4.6 m).

Height: Usually 3 storeys.

Floor area: Average 450 sq ft (about 40 m²) per floor.

1. A smaller building built on a site fronting a narrow side street (which precluded the construction of verandahs or balconies).
2. A flat facade with no verandah or balcony.
3. The kitchen takes up half the width of the back of the building, and opens into the back lane and the open space at the back of the building.
4. Not equipped with toilet.

Example: 6-8 Hing Wan Street (Yellow House).

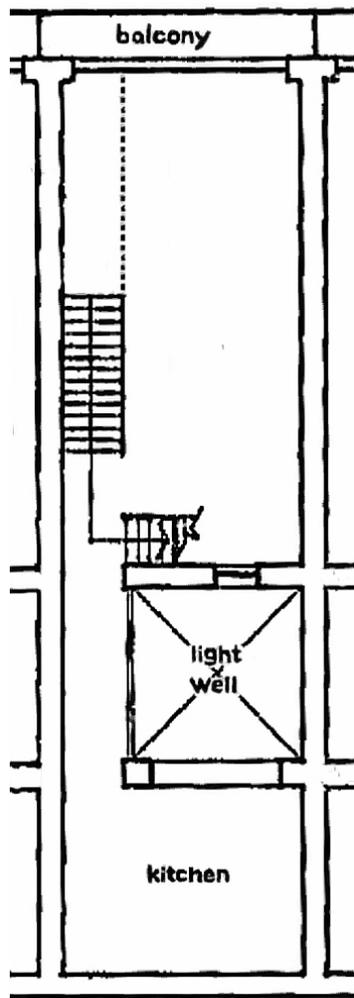
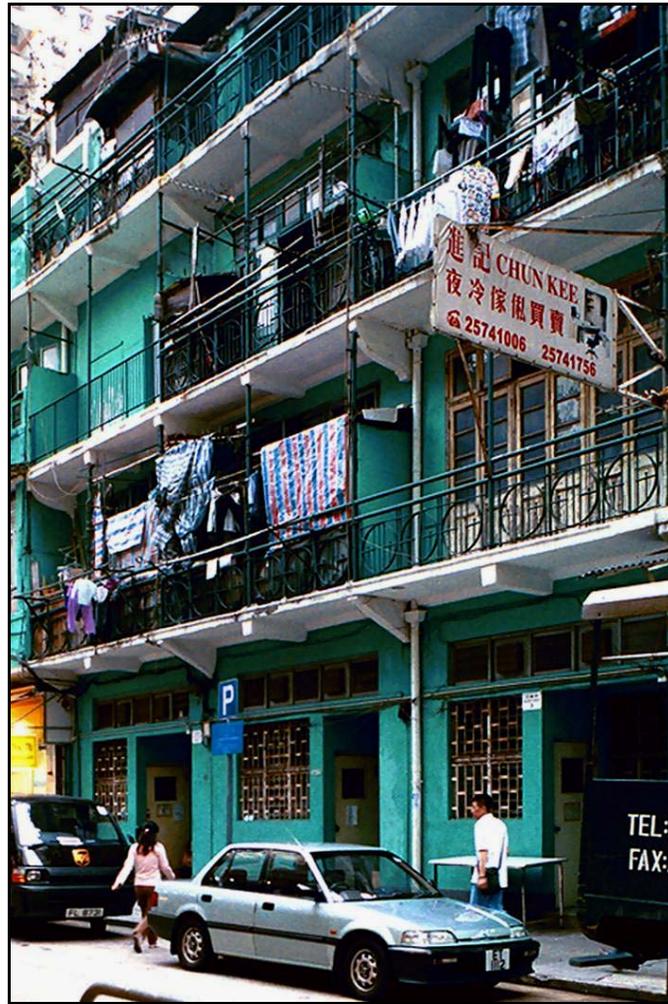
5.5 Cantilevered Balcony Type with Suspended Wrought Iron Posts

Date: After 1903 and before 1935, but mostly the 1920s.

Structure: $1\frac{1}{2}$ ft (about 0.5 m) load bearing brick party wall with round fir floor beam; balcony of reinforced concrete reinforced by suspended wrought iron posts.

Frontage: 15 ft (4.6 m).

Height: Usually 3 storeys.

Floor area: 450 to 650 sq ft (about 40 to 60 m²) per floor.

- Features:
1. Built along narrow side streets which allow the construction of balconies but not verandahs.
 2. Narrow cantilevered balcony of about 2 ft deep.
 3. For buildings on a deep site, a light well separates the living area from the kitchen, so that living area and the kitchen are treated as separate blocks and thereby enables the building to comply with the building depth restriction.
 4. The kitchen may be the same as that in 5.4, or, in the case of a deep site, may be a separate block that takes up the entire width of the back of the building, and opens into a light well.
 5. Not equipped with toilet.

Example: 1-11 Mallory Street (Green House); 72-74A Stone Nullah Lane (Blue House).

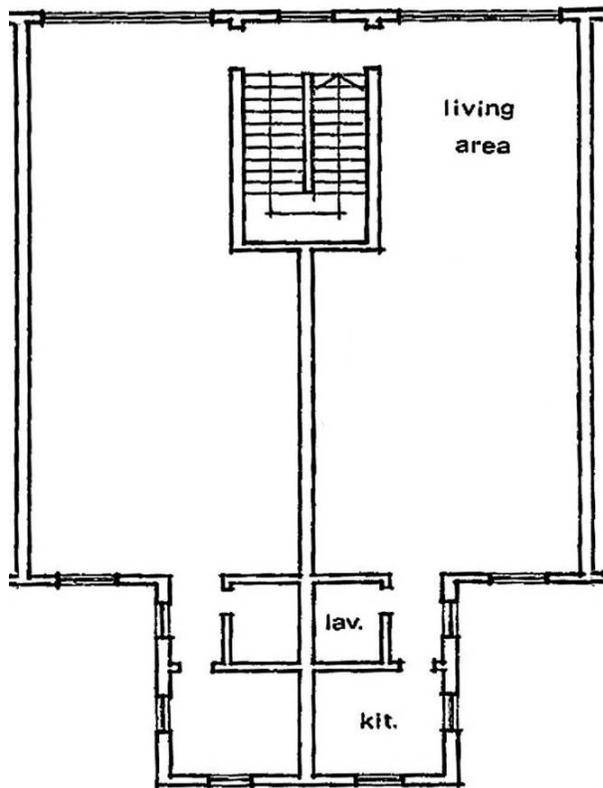
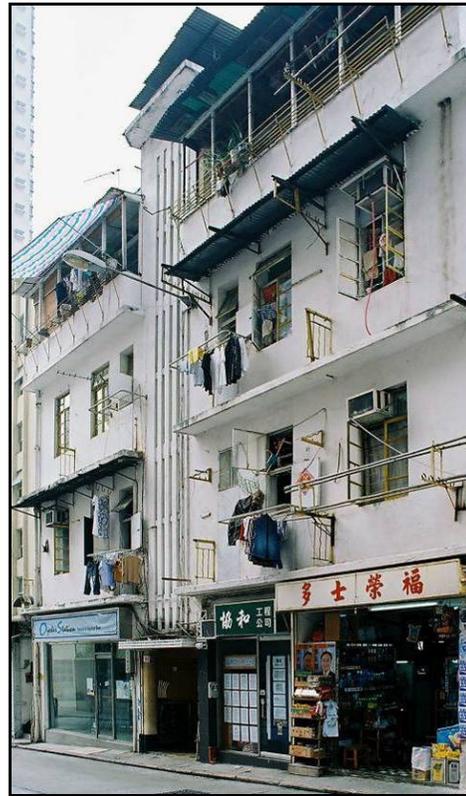
5.6 Reinforced Concrete Type with Stairwell on the Facade

Date: 1935-1955.

Structure: Reinforced concrete.

Frontage: 16 ft (4.9 m)

Height: 3-4 storeys.

Floor area: 550 to 700 sq ft (about 50 to 65 m²) per floor.

- Features:
1. Frontage width increased due to reduced width of living area to accommodate a naturally lit and ventilated stairwell on the facade.
 2. A dog-leg staircase shared by two blocks and opens into the fronting street; this design is a result of the requirement under *Building Ordinance 1935* for staircases on every floor to have adequate natural lighting and ventilation.
 3. The kitchen takes up half the width of the back of the building, and opens into the back lane and the open space at the back of the building.
 4. A toilet, equipped with toilet and sanitary fittings, separates the living area from the kitchen.

Example: 29-31 Bridges Street; 3-12 Wing Lee Street.
